**SAS Superstructure**

Daily Diary Report by Bid Item

Contract No.: 04-0120F4

Diary #: 096 Const Calendar Day: 576 Date: 07-Apr-2011 Thursday

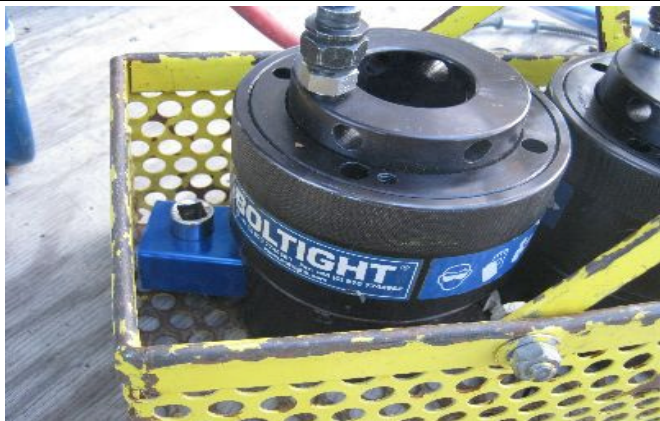
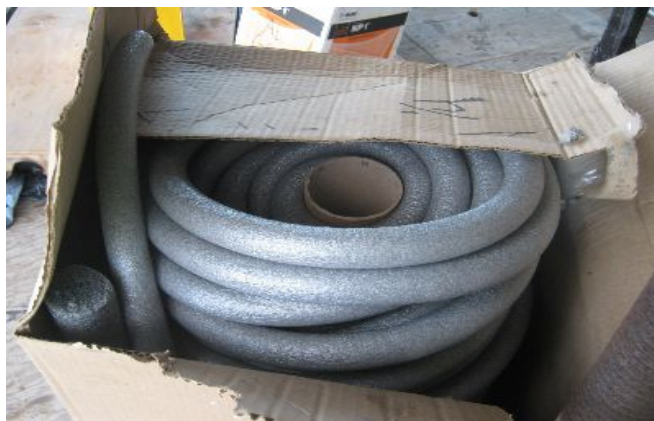
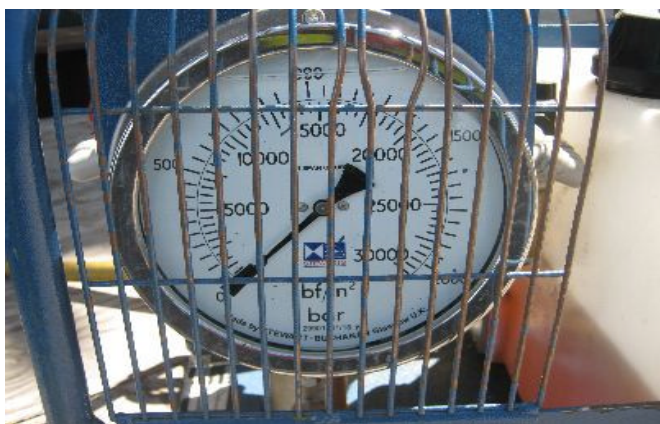
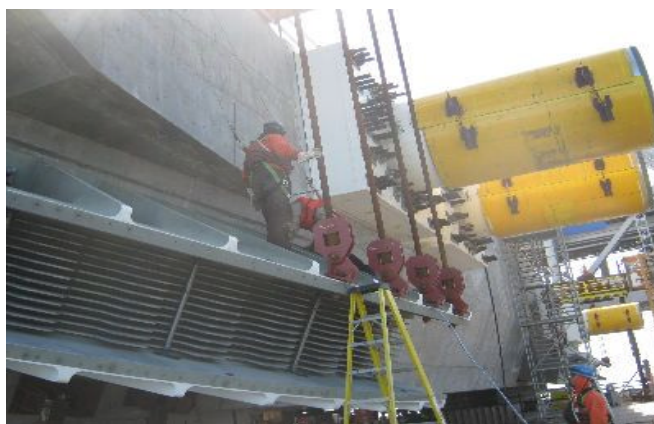
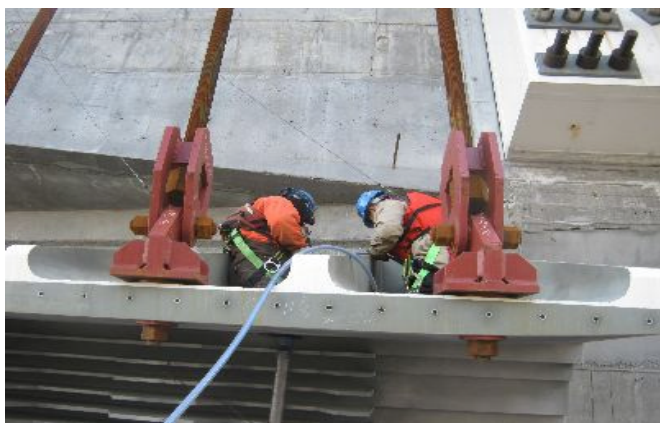
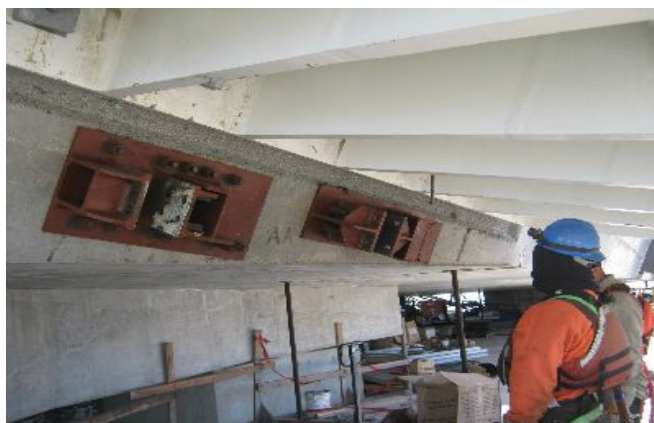
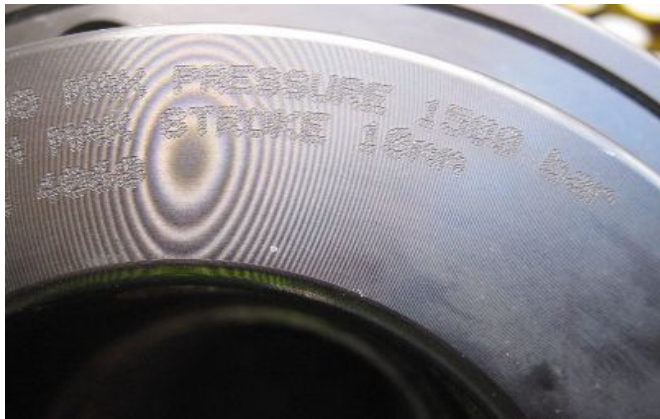
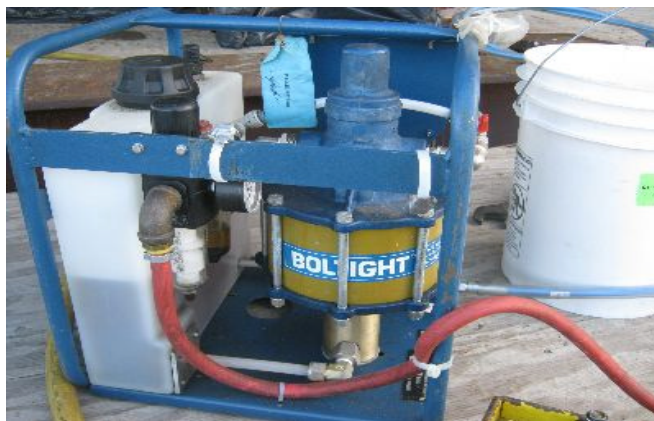
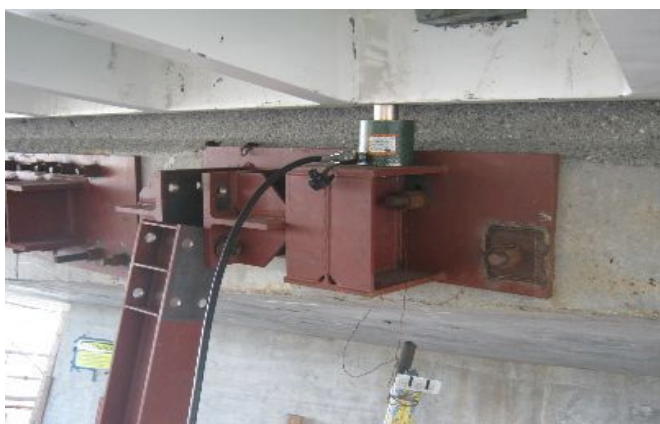
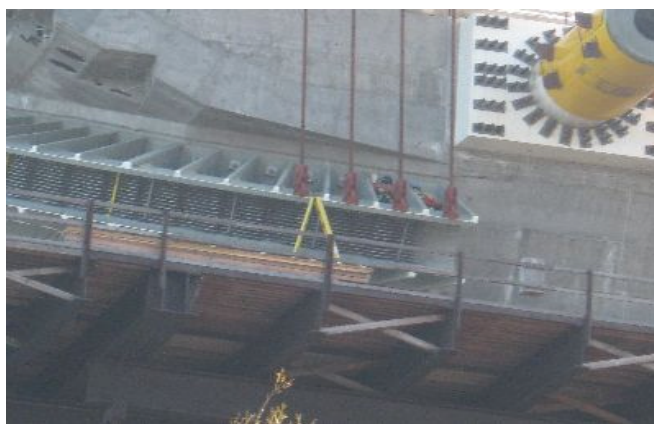
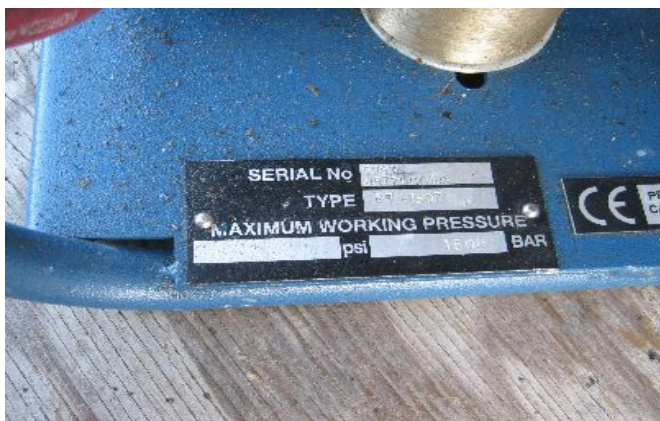
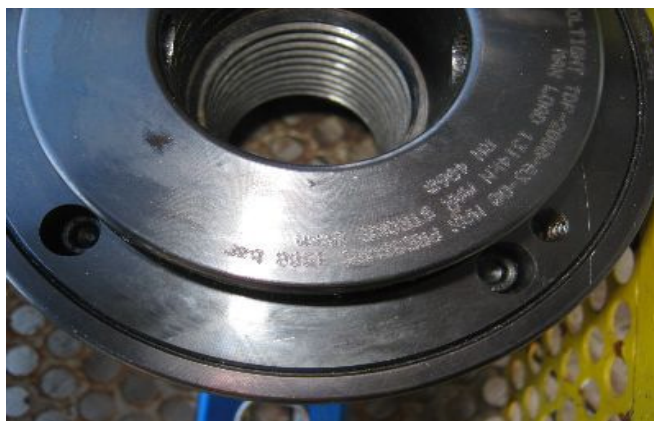
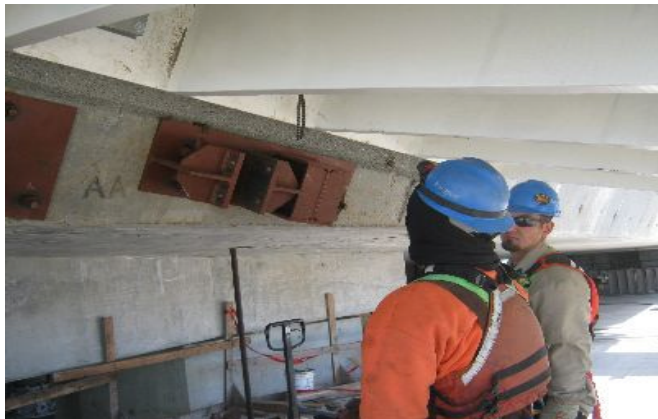
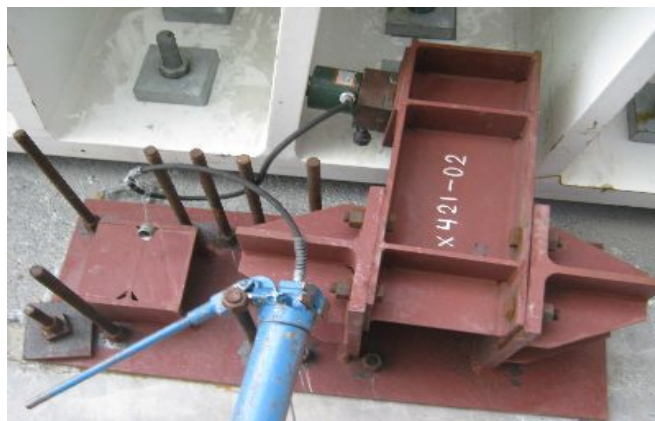
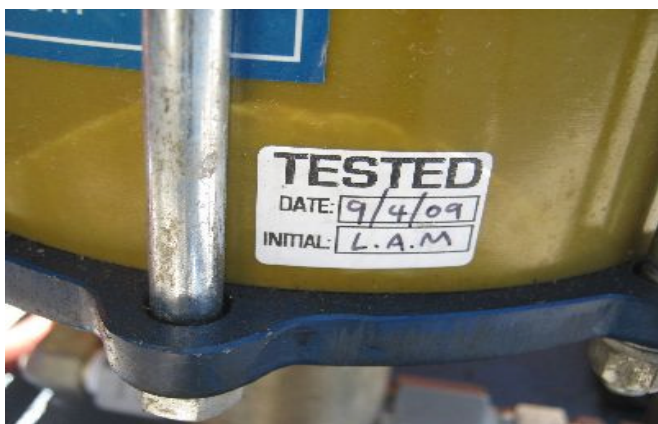
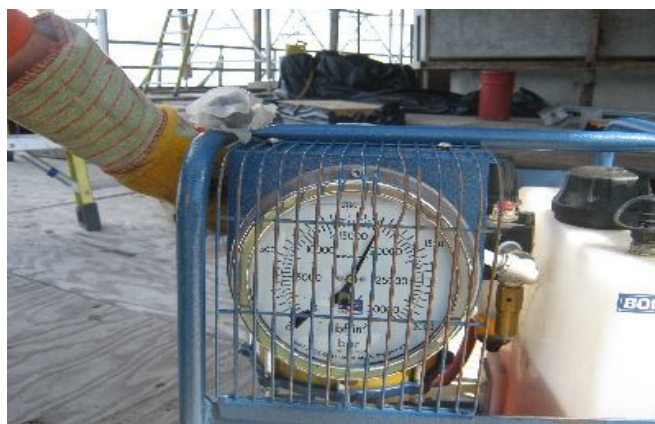
ABF crews have pre-tensioned four top upper row of the saddle anchor rods up to gage pressure of 17500 psi (0.75Fu) at West side of the W-line saddle and four at the same position at the East side of the W-Line saddle. From eight pre-tensioned only two have shims on the back of saddle end plate prevent creation of minor stress at the saddle end plate. However, for the other six anchor rods there is no shim on the back of the saddle end plate, which causes unknown magnitude of stresses at the saddle end plate. The stresses might be in the elastic range, however it was necessary to add shims behind these anchors to transfer any load through shims to pier, thus minimizes and stress effect on the saddle end plate. Although, the bearing stresses under the shims become high, but it would be in the acceptable range.

ABF crews repeated similar procedure today by pre-tensioning the four top lower row of the saddle anchor rods up to 17500 psi while there no shim on the back of the saddle end plate and still the upper four anchor rods are in the pre-tensioned condition. Simply eight anchor rods at one corner of the saddle are pre-tensioned which increases the saddle end plate stresses to a much higher level.

The reason for this operation was mainly trying to fill up the gap between the saddle end plate hole and the upper row anchors in order to prevent locking of the anchors by the grout and any grout leakage.

The crews dismantled the lower jacks and the removed the supporting brackets of these jacks to make it reading for CONCO crews to start forms around the saddle. Please see the attached pictures for more details.
